Danube east of Vienna

Navigation issues and other insights

Wolfgang Rehm

RUSE, October 1st/2nd 2009

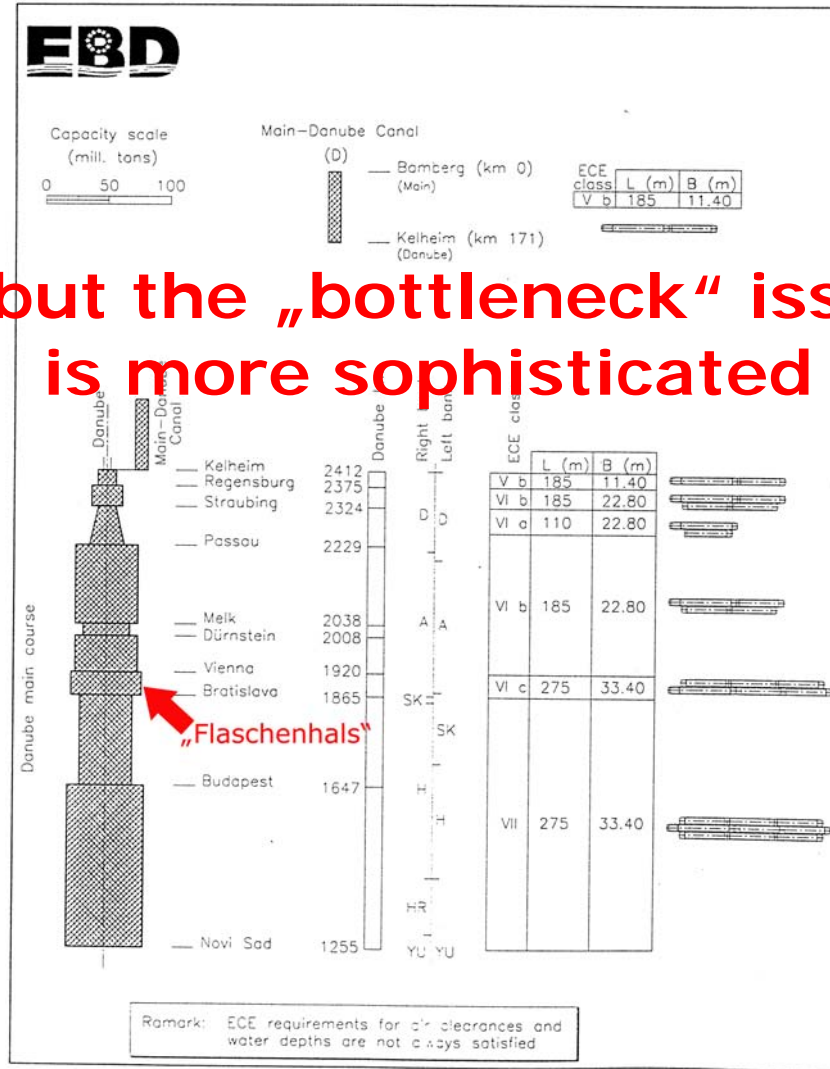
Figure 2.1a:
Schematic review of the Danube waterway capacity from km 2412 to km 1255

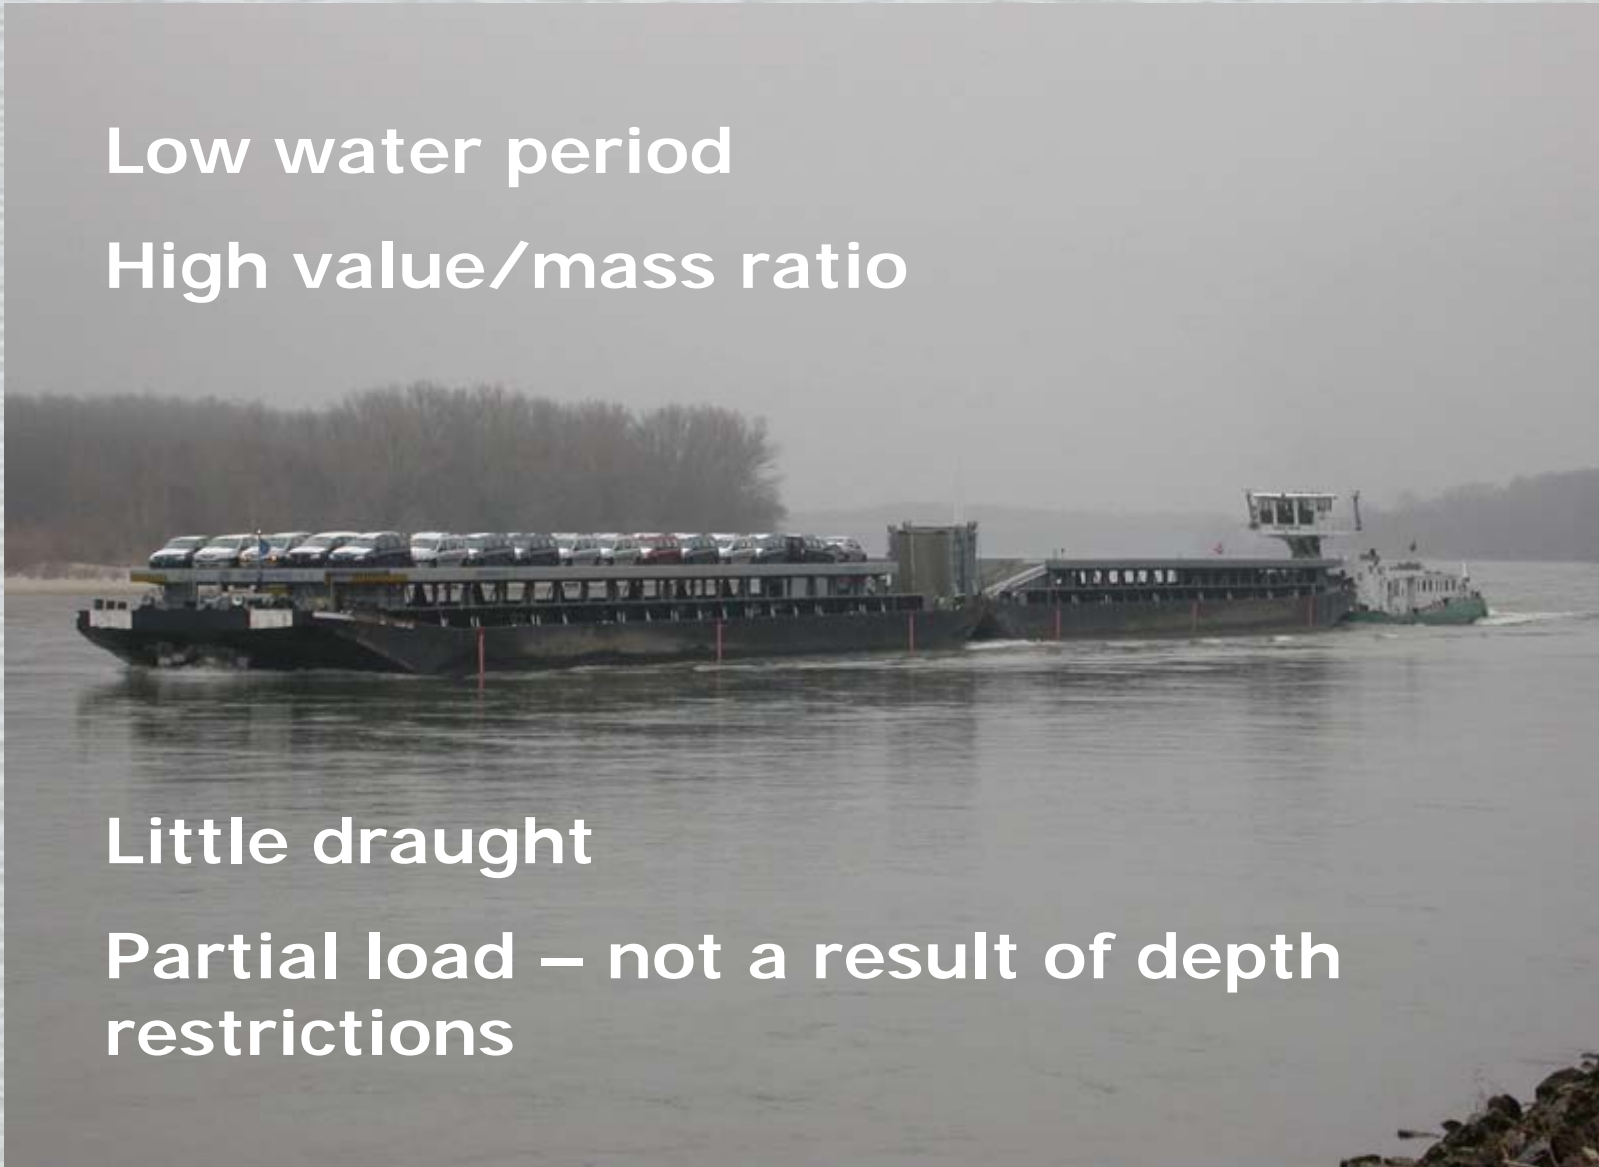
Case 1: Ro-Ro vessel convoy

Low water period

High value/mass ratio

Little draught

Partial load – not a result of depth restrictions

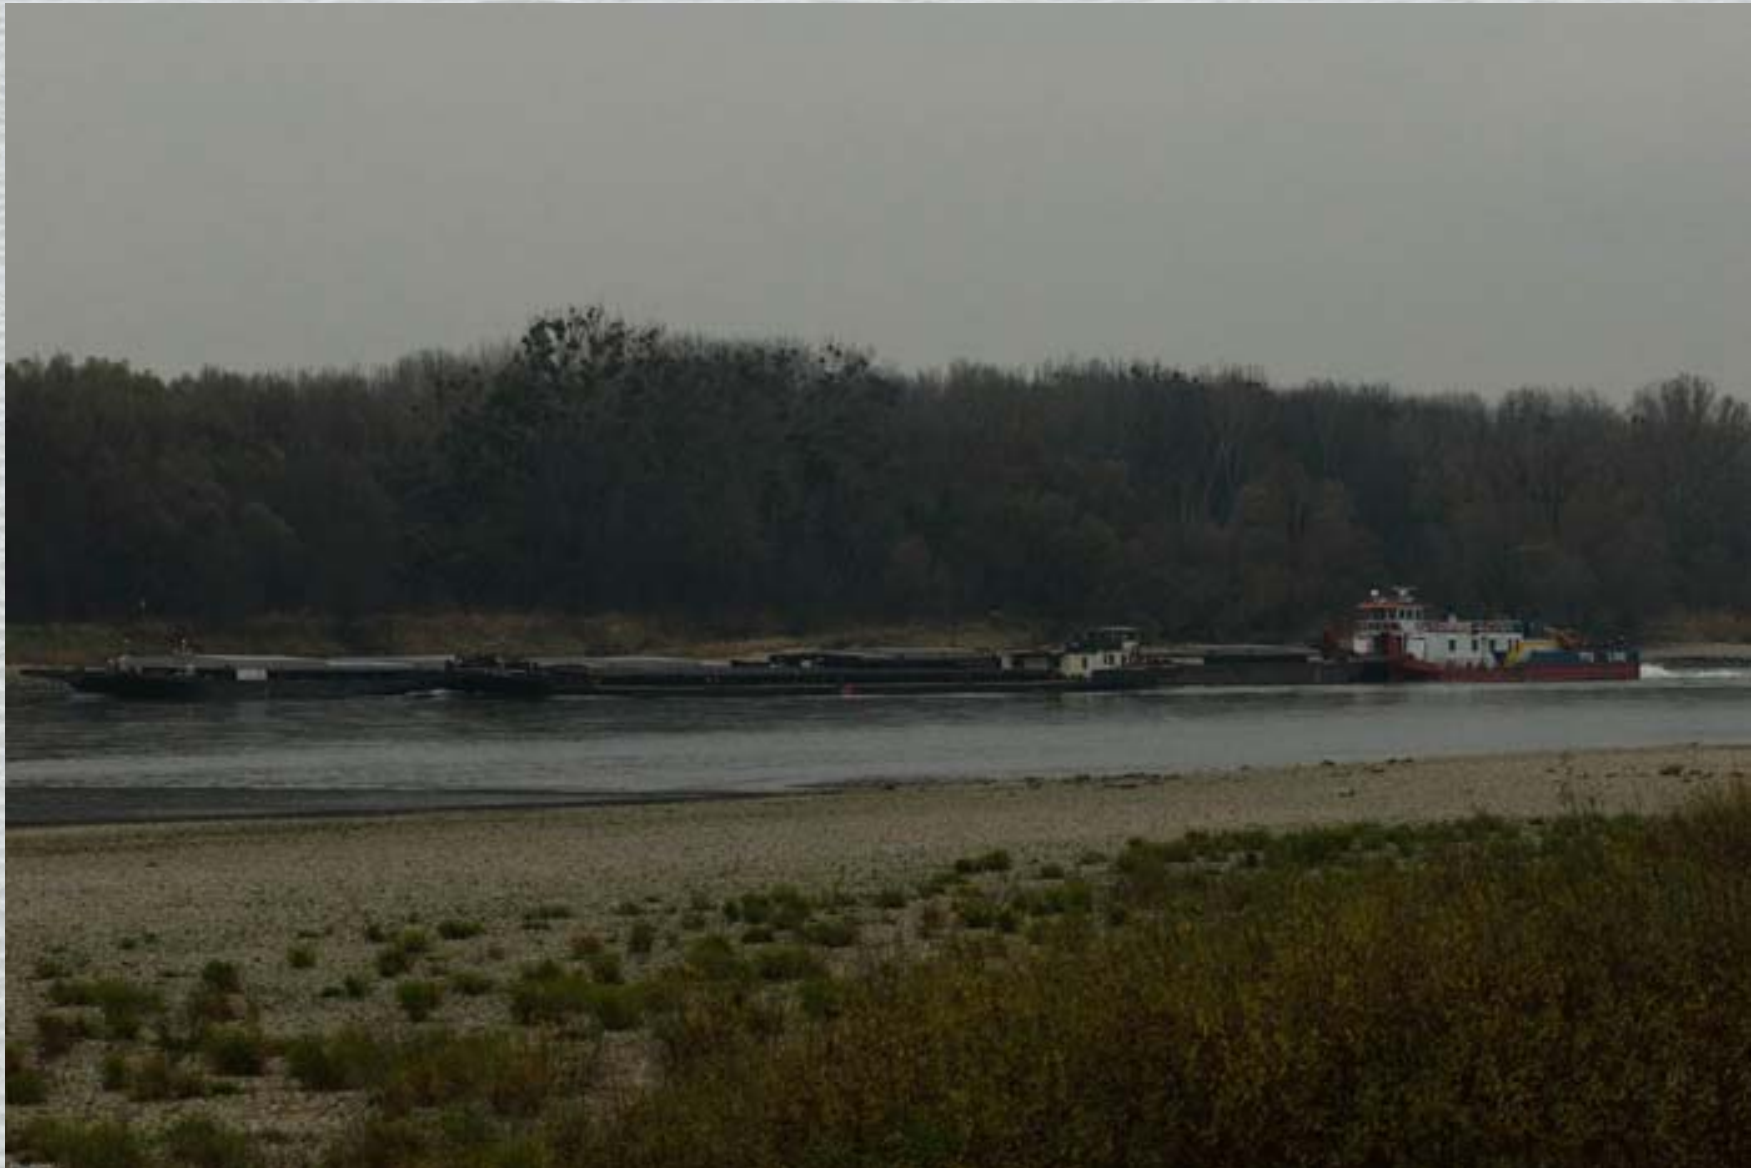
Case 2: Convoy of three pushed barges

Convoy draught indicator and situation

LNRL depth

„Current Status“: claimed to be 2,5 m

LNRL depth real: 1,9 m

Depth on specific day : 1,85 m

Draught of barges: 2,1 m!

Available „minimum depth“ exceeded!

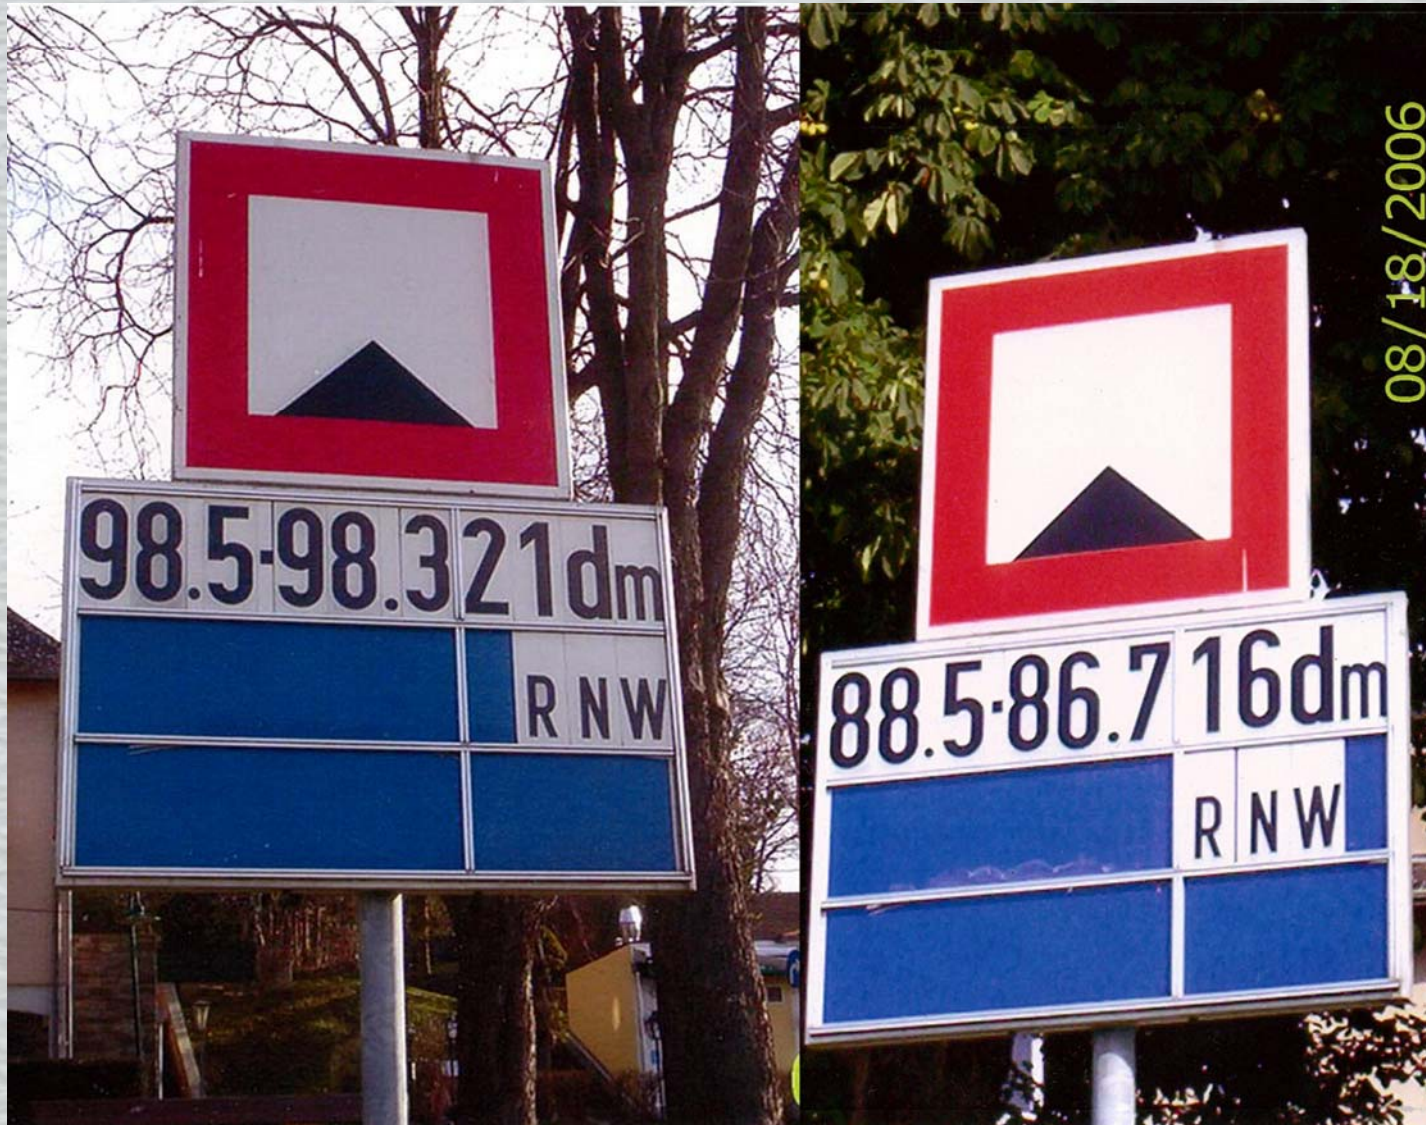
Navigation signs (Hainburg)

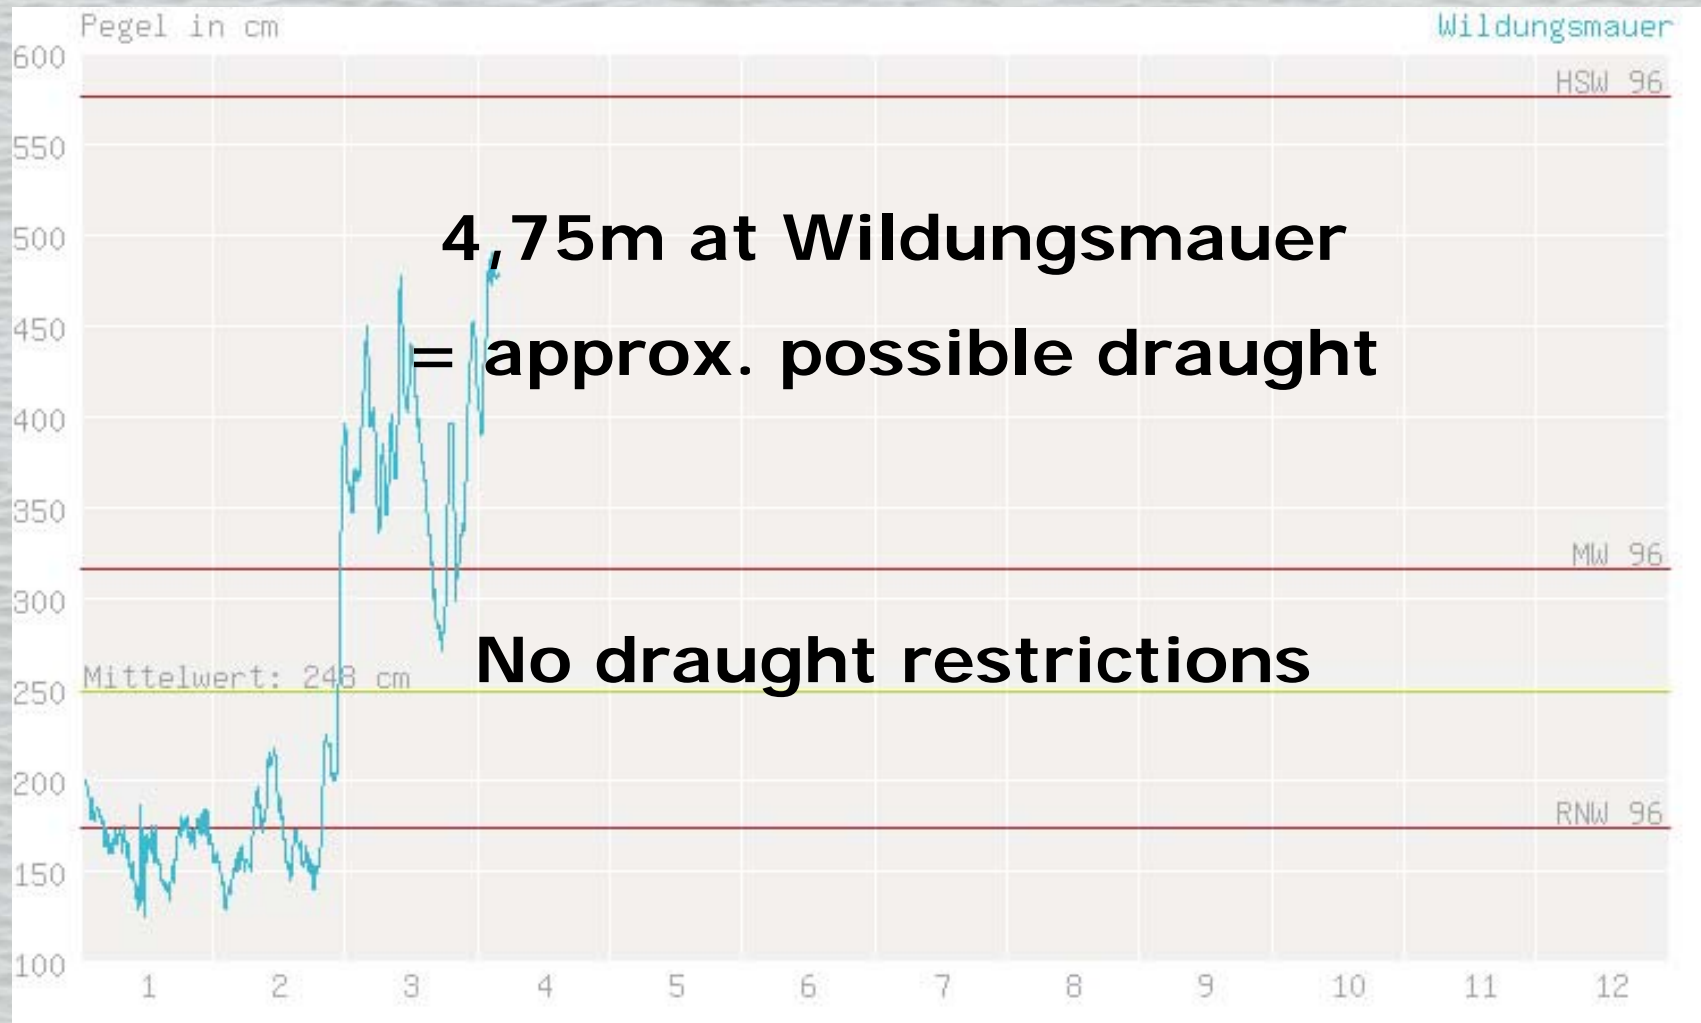
Case 3: April 2009

Data and graphics: via donau

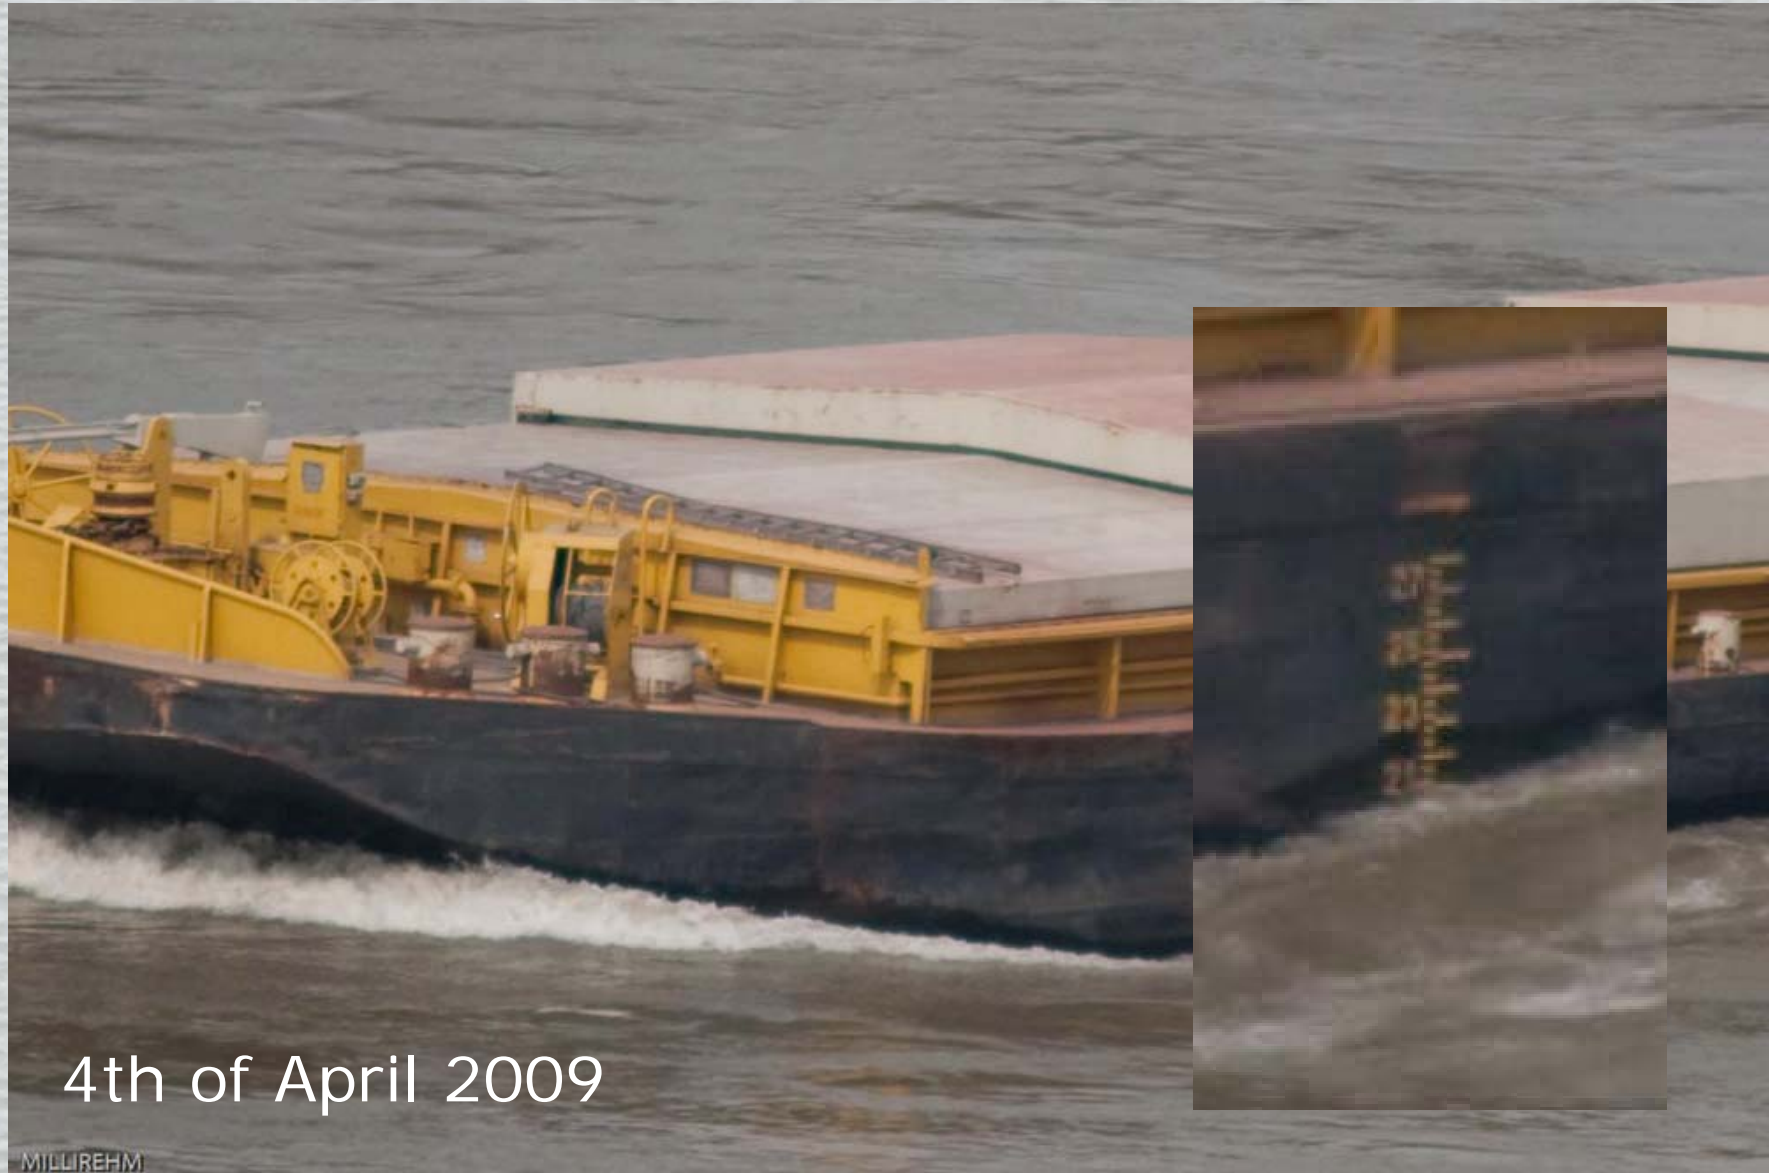
Pushed barge - level above middle water

4,5 m available - still only 2,1 m draught

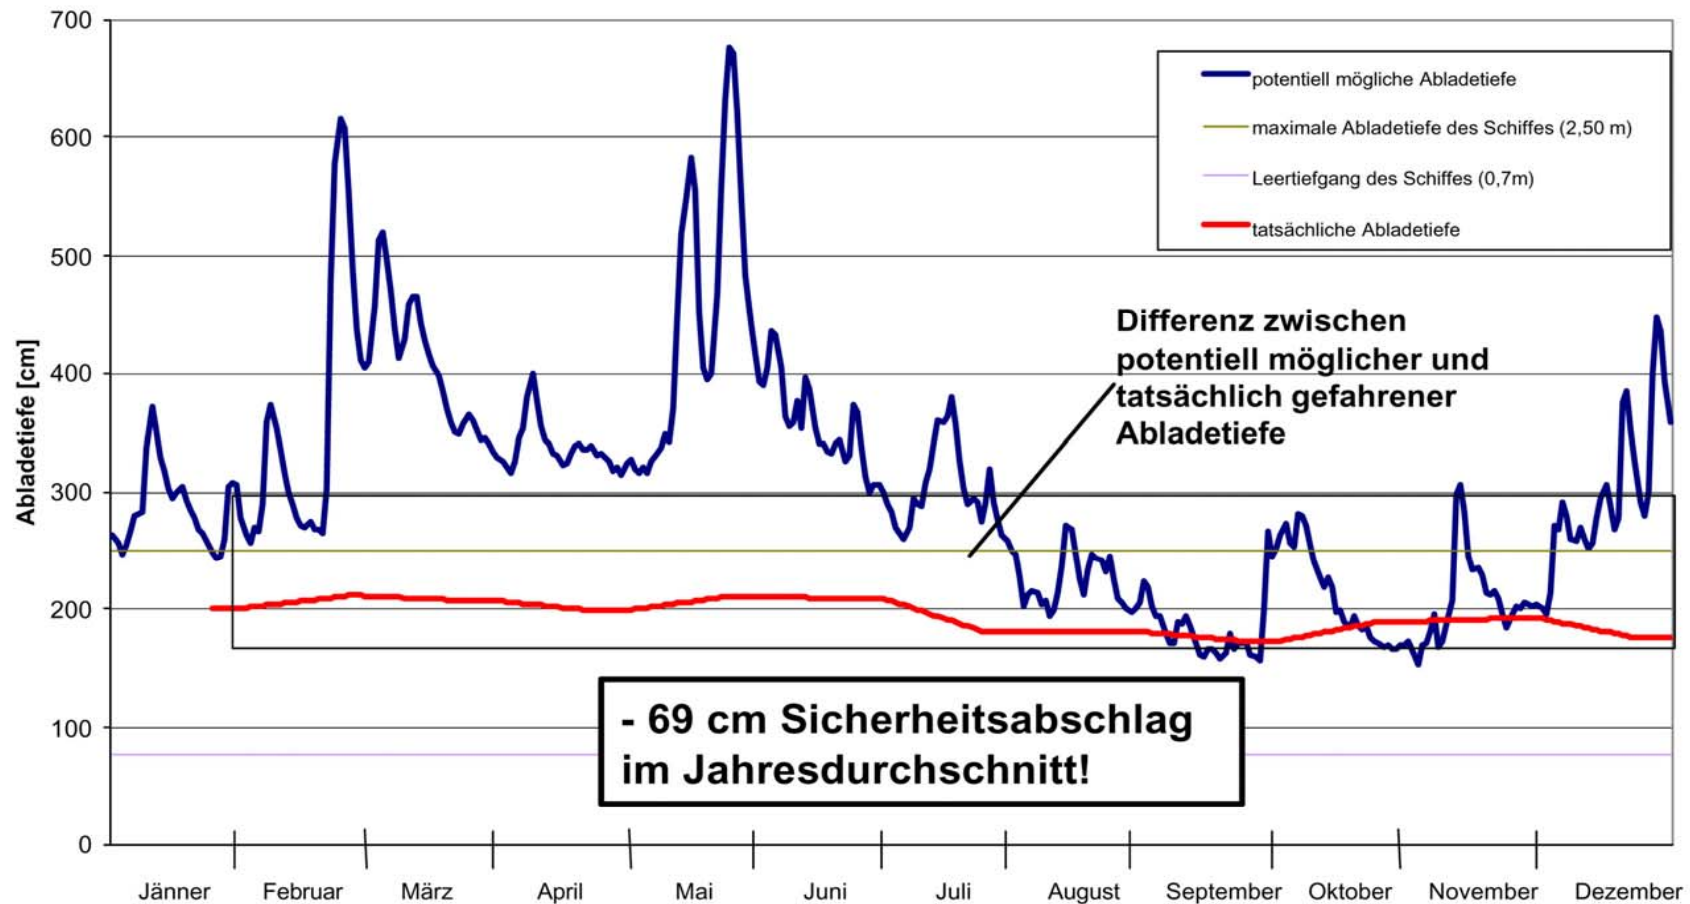
Unsicherheiten hinsichtlich der Wasserstandsprognosen Obere Donau (2)

Vergleich potentieller Abladetiefe zu tatsächlicher Abladetiefe im
Langstreckenverkehr 1999

Draught discrepancies

Available draughts are not always used due to:

- Uncertainty, limited range of prognosis

- Technical limits

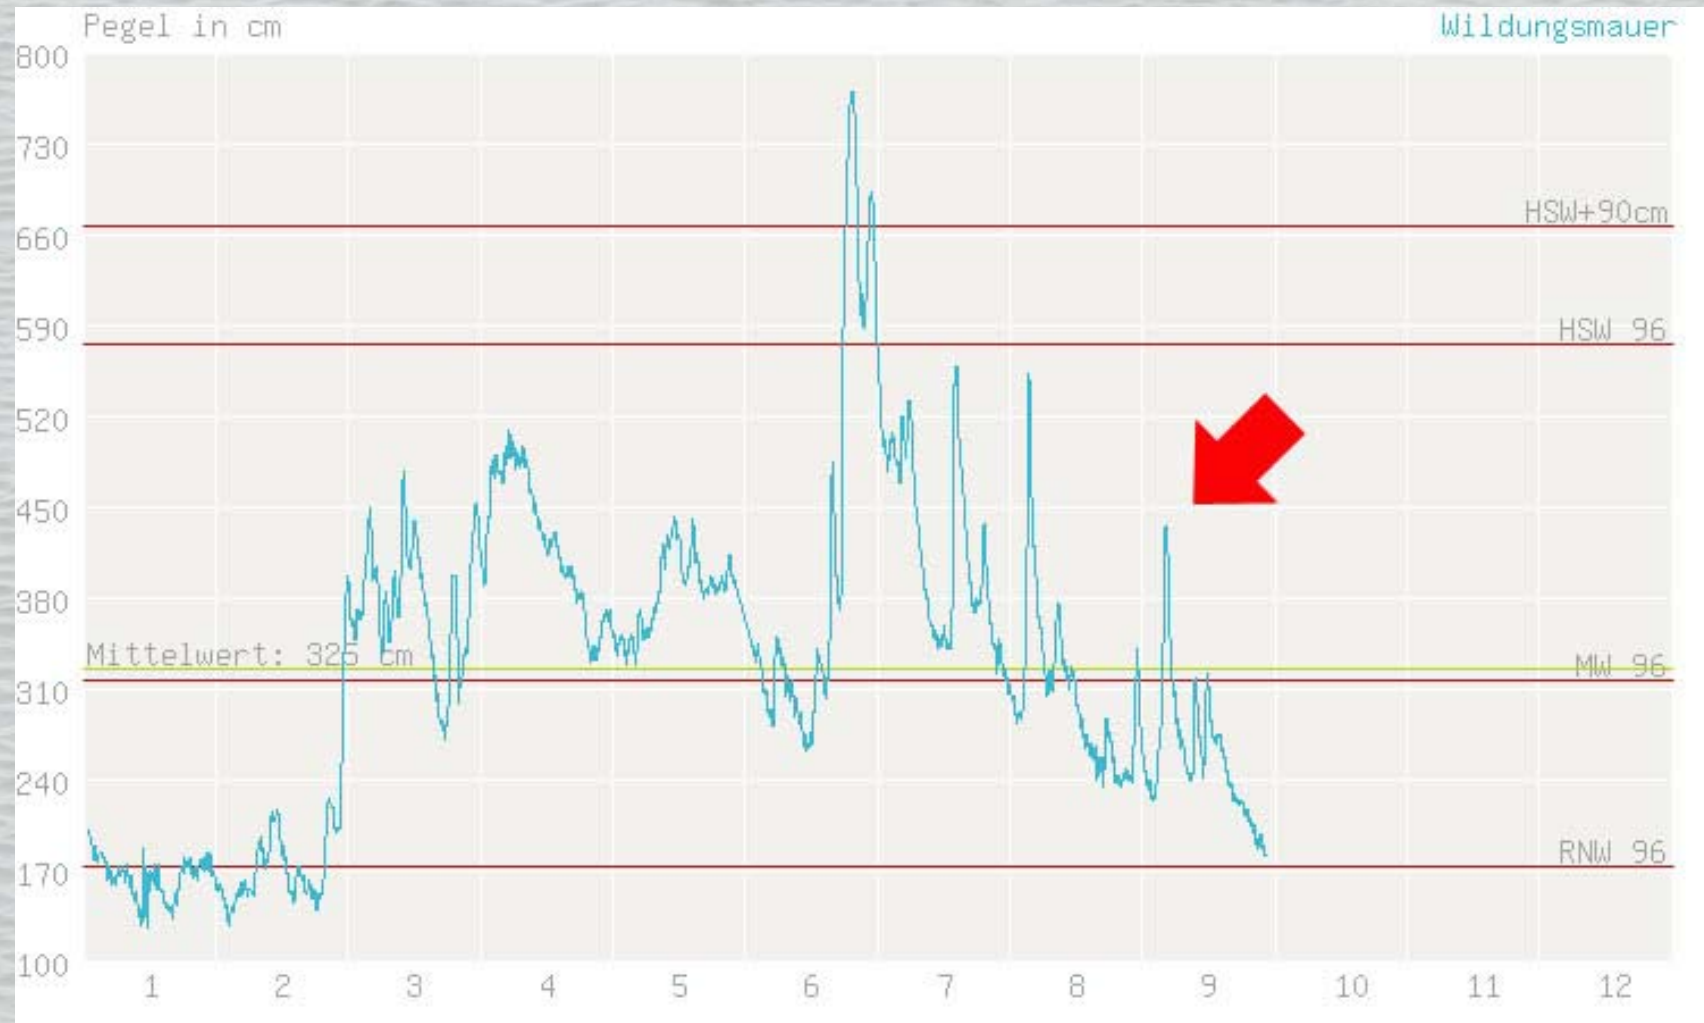
Case 4: Are peaks used?

Data and graphics: via donau

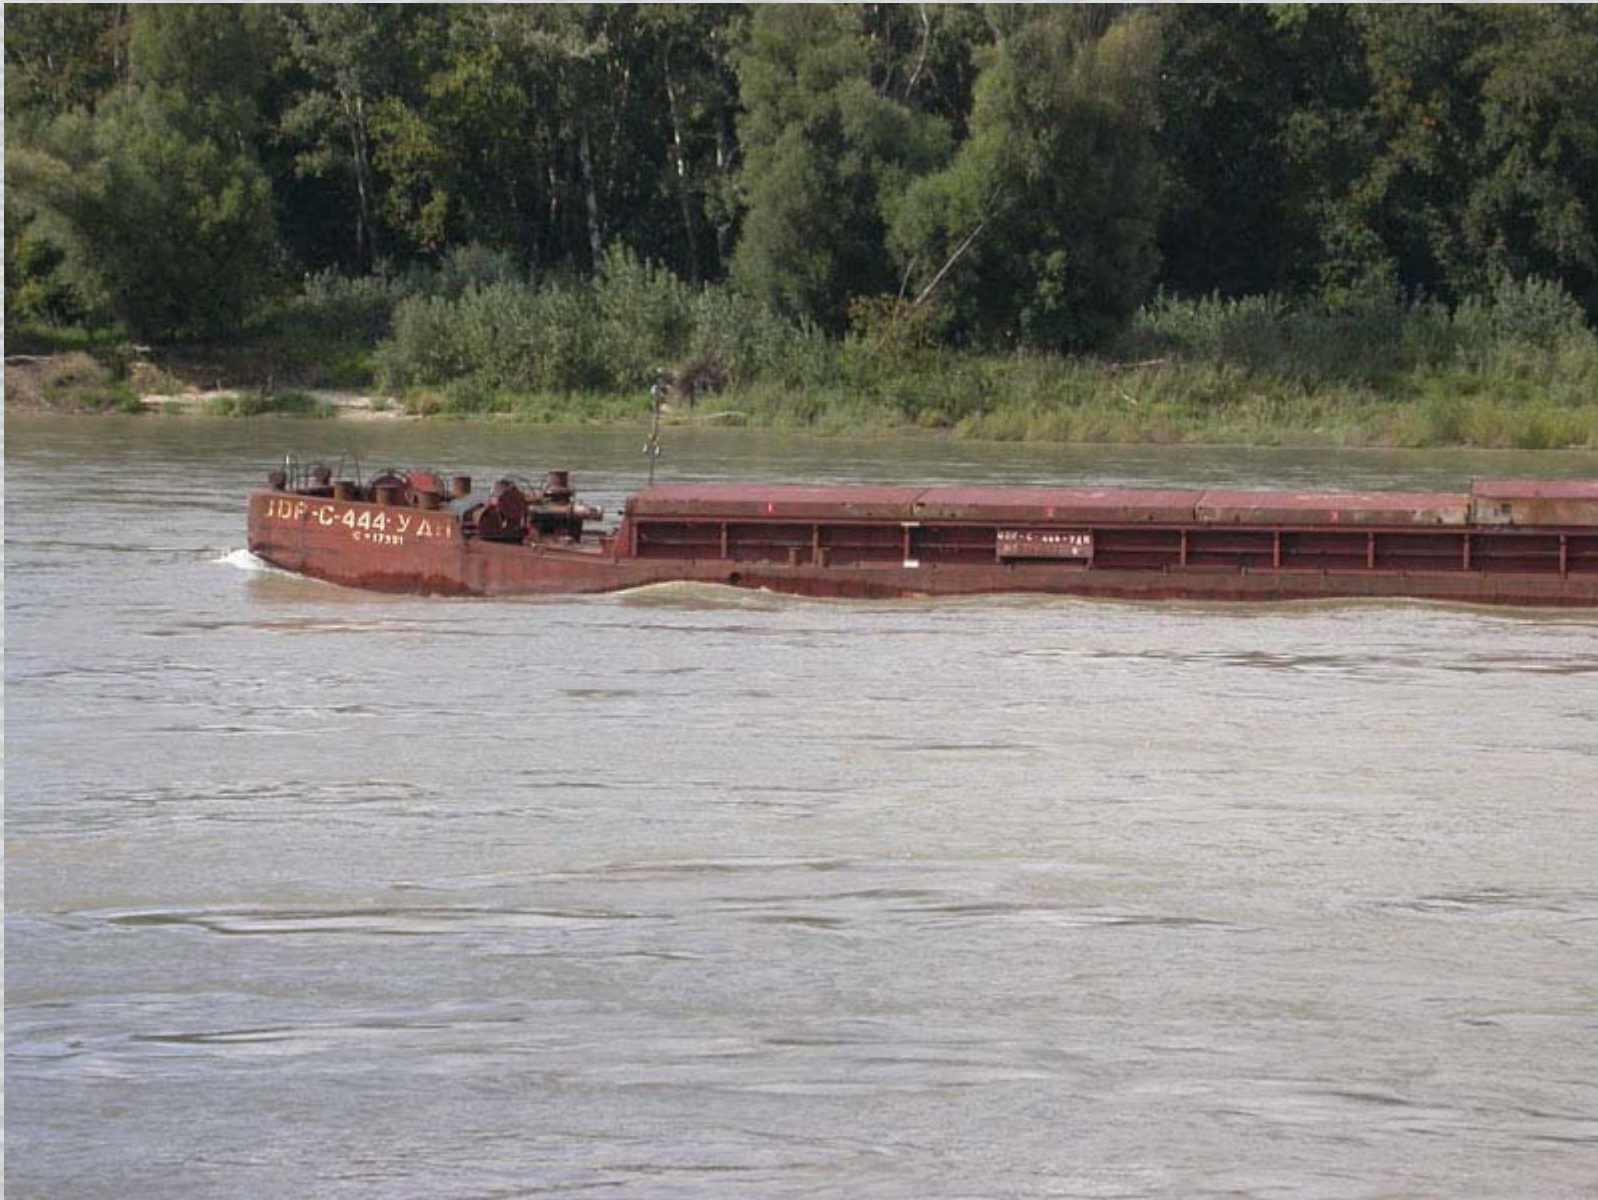
Case 4: Convoy of 2 pushed barges

Full draught 2,7 m
